## STUDY OF THE FRACTURE FACIES WHEN DRILLING C-ORTHOCRYL CARBON-RESIN COMPOSITE MATERIAL FOR ORTHOPEDIC PROSTHESIS

**Key words:** drilling, mechanical testing, SEM, delamination, injection molding, orthopedics.

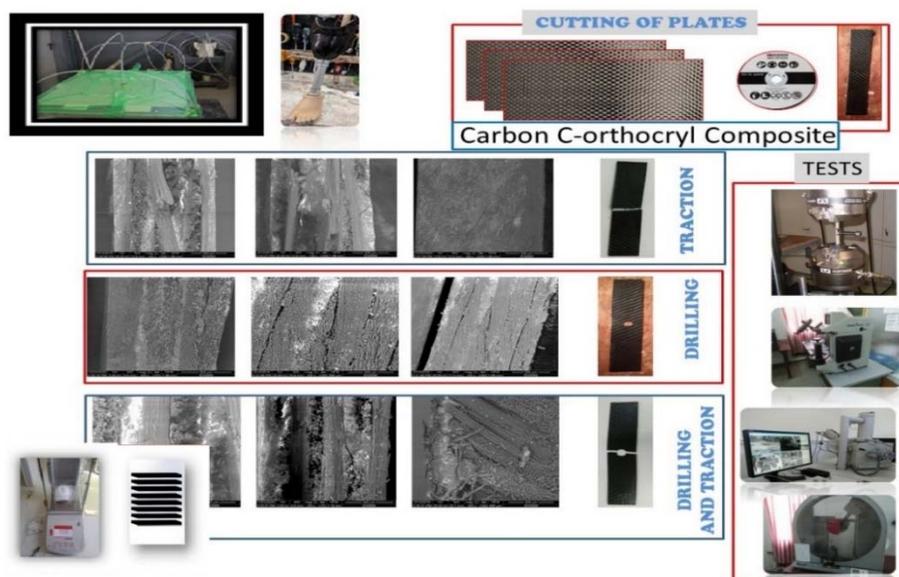
Fig.1. Manufacturing process for the carbon c-orthocryl composite.

In this study several steps were deployed to fabricate the laminate composite according to manufacture specifications [37] the carbon composite was composed of a weight fraction of 35% carbon woven tissue and 63% of c-orthocryl resin 617H55, adding 2% hardener powder 617P37 at a ratio of approximately 100:2 by

weight (2% hardener)[38]. Laminated composite plates were stacked together by the vacuum infusion process with three layers of carbon, with a vacuum of 0.8 bar and a polymerization in an oven at 80°C for 8 hours in an autoclave to facilitate the curing of the composite layers also reducing the generated porosity between the stacks, Fig.1 shows an explanation of the manufacturing process. These guidelines provide a consistent baseline for laboratory (onnaph) processing of carbon-orthocryl composites, ensuring both safety during curing and reproducibility of the mechanical performance [39].

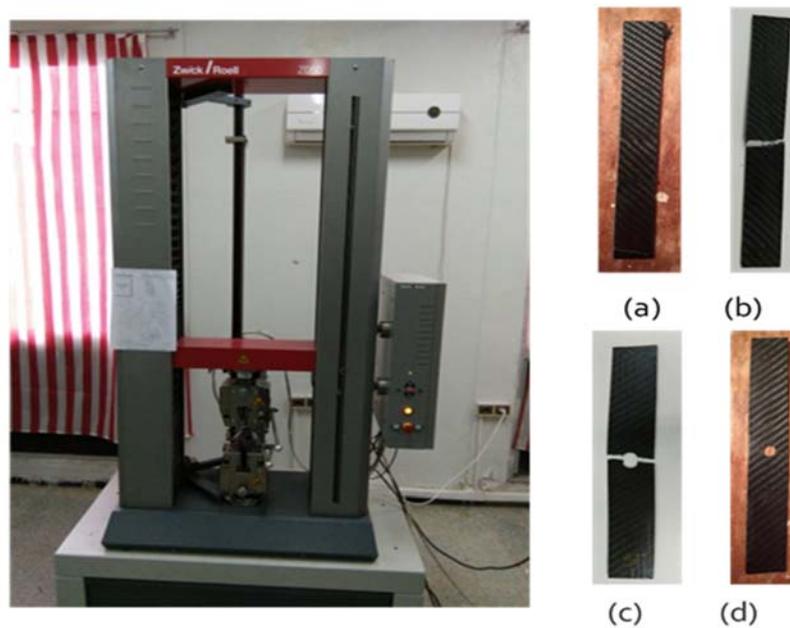
Fig.2. Different specimens and tensile machine Zwick/Roell Z050.

The tensile tests were conducted on a Zwick/Roell universal machine model Z050, equipped with a 50 kN force cell (Kennesaw, USA), as shown in Fig.2. The tests were performed at a loading speed of 2 mm/min under laboratory conditions at room temperature. The test concluded following a substantial decrease in the applied load. Engineering stress-strain data can be derived from the load-displacement information recorded by the testing machine; the number of tests is limited due to the high cost of the material. The tensile modulus is determined by calculating the slope of the resulting stress-strain curve, the stress-strain curve calculated, and tensile strength and modules following the following Eq.(2.1) of CFRP for both of the specimens drilled and conventional, according to [40], can be calculated within a strain range from 0.0005 to 0.0025. The details of the specimens before and after the test are shown in Fig.2(b-c). B. Huang investigated the tensile properties of the unidirectional CFRP plates with different lengths. Among these specimens, for the 150 mm length, the tensile strength  $\sigma_{max}$  results vary from 2819 MPa to 2598 MPa [42], also demonstrated that intralaminar and interlaminar defects arise during static tensile testing of carbon fiber reinforced polymers (CFRP) as a result of macroscopic voids present between the layers. These voids create regions of stress concentration, which can significantly compromise the material's tensile resistance. Therefore, it is imperative to minimize the occurrence of such voids during the Manufacturing process of the composite [43]. All the results are summarized in Tab.2. The tensile stress-strain curve is illustrated in Fig.6.

The protocol to be followed was to divide the specimens into four lots. The first lot serves as a control Fig.2(a), the second will be subjected to a static tensile test Fig.2(b), the third will be drilled and subjected to a static tensile test Fig.2(c) and the fourth will be drilled by 8 mm HSS twist drill bit Fig.2(d), the four specimens will be examined under the SEM electron microscope to detect the various defects existing after molding and the damages generated within the material by the drilling and tensile tests and to find the necessary solutions [18-22]. SEM images were taken using a high-resolution microscope vacuum system QUANTA 250 from FEI Company (Hillsboro, Oregon, USA). SEM observation of the damaged areas around the drilled holes revealed an obvious delamination concentration around this area. Furthermore, another shear crack appeared, indicating fiber failure in the direction of the applied tensile force.

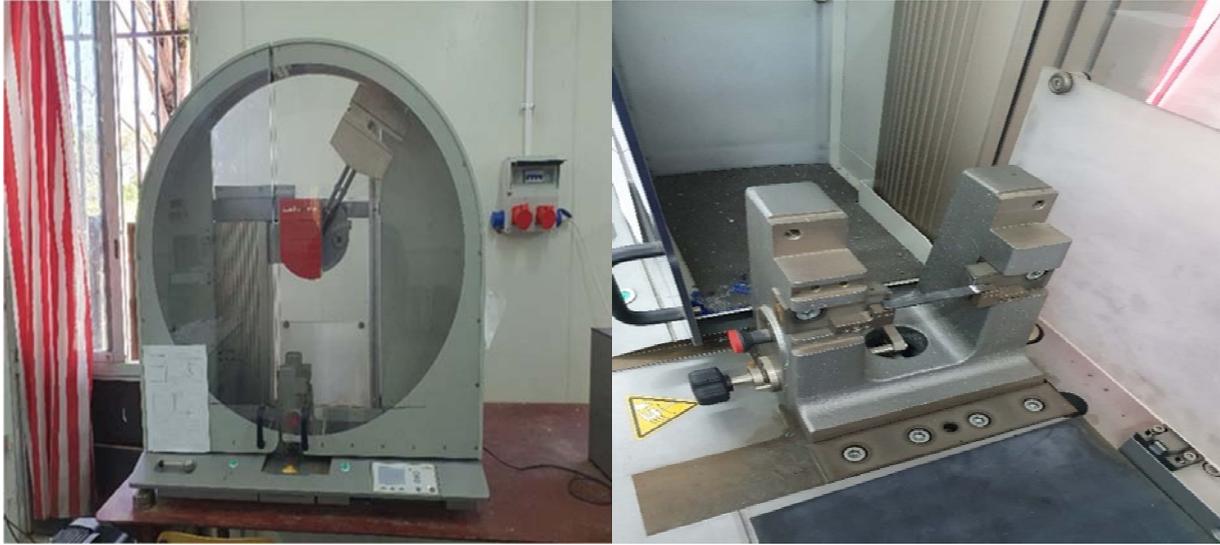
Fig.3. Zwick/Roell impact testing machine.

The primary challenge in testing composites using the Charpy impact test is the complexity of failure modes, which often include delamination, matrix fracture, and fiber tearing. Additionally, delamination tends to decrease as the thickness of the laminate increases the goal from the test is to determine CFRP resistance to impact and the absorbed energy calculated with formula (2.2) following the previous studies [44, 45] the specimens were made According to [41] with dimension  $77 \times 10 \times 3 \text{ mm}$ , the specimens were cut using a diamond saw, impact device is Zwick/Roell HIT50P testing machine with an impactor energy level of 50 joule and a constant mass of 60 kg and pendulum length 800 mm and constant speed with a fixture stand and support base the specimen were placed in the front of the impactor to insure complete contact between impactor and specimen Fig.3, all the results are summarized in Tab.3.

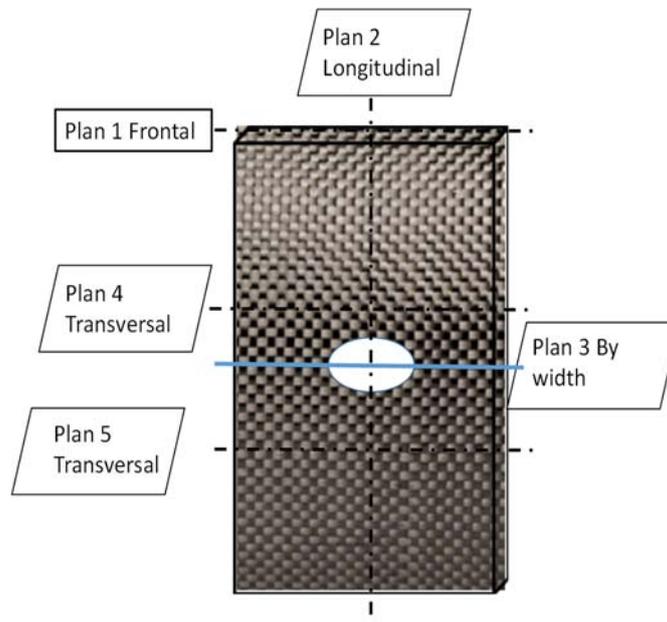
Fig.4. Different surfaces according to the cross-sectional planes of the tensile specimen.

We cut the control specimen in the longitudinal, transverse, and frontal directions, as shown in Fig.4. This cutting allows us to know the internal structure of the material and to detect possible molding defects along the various facies and fiber orientation across the plies. It exposes the fibers with a significant amount of c-orthocryl resin.

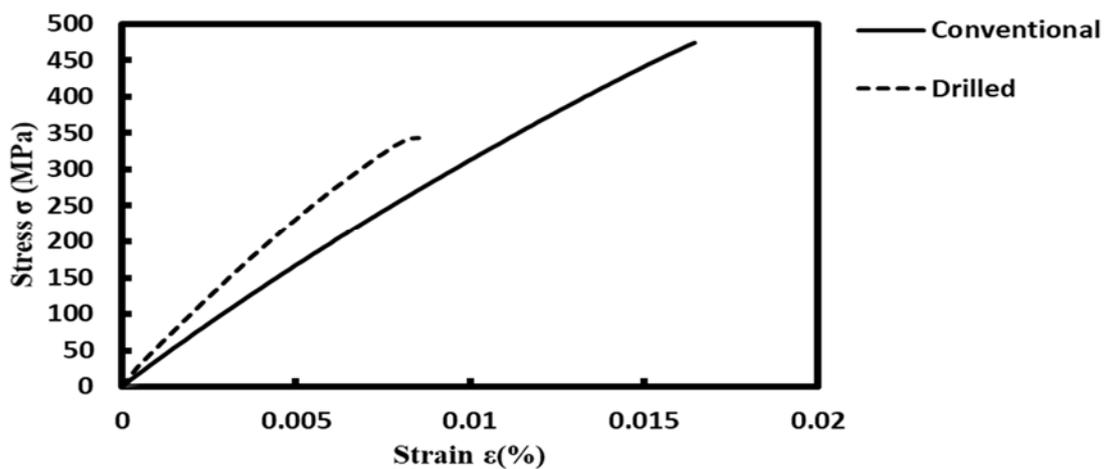
Fig.5. Tensile stress-strain curve for the carbon c-orthocryl composite.

The tensile test results for the carbon fiber c-orthocryl resin composite show that the regular sample has an average tensile strength  $\sigma_{max}$  of 437.539 MPa, an average Young's modulus  $E$  of 35.811 GPa, as shown in Tab.2 based on the linear part of the stress-strain curve illustrated in Fig.5. The strain to failure is 1.7%, which is typical of brittle behavior. Many factors can have significant impacts on the tensile strength of CFRP, including the environmental conditions and how it is processed mechanically. Li *et al.* [46] examined the impact of environmental conditioning on CFRP, demonstrating that tensile strength decreases with extended exposure to hydrothermal conditions, suggesting more significant effects on tensile strength when sustained loads are combined with hydrothermal aging. Additionally, the drilling process can cause damage mechanisms like delamination and micro-cracking, which change the material's tensile characteristics. Ueda *et al.* observed that drilled specimens frequently exhibit reduced tensile strengths relative to their non-drilled equivalents, ascribing this phenomenon to the onset of damage mechanisms during the drilling process [47]. Drilling an 8 mm hole in the specimens creates a stress concentration that reduces the average  $\sigma_{max}$  by 17.42% (to 361.286 MPa) and the strain to failure by more than 52% (to 0.8%). The discontinuity serves as a crucial initiating point for crack propagation and early fracture, emphasizing the composite's vulnerability to geometric defects and the necessity of incorporating such characteristics in structural design. Evidence indicates that the drilling procedure influences both the load-bearing capacities and the strain properties of the CFRP matrices [48].

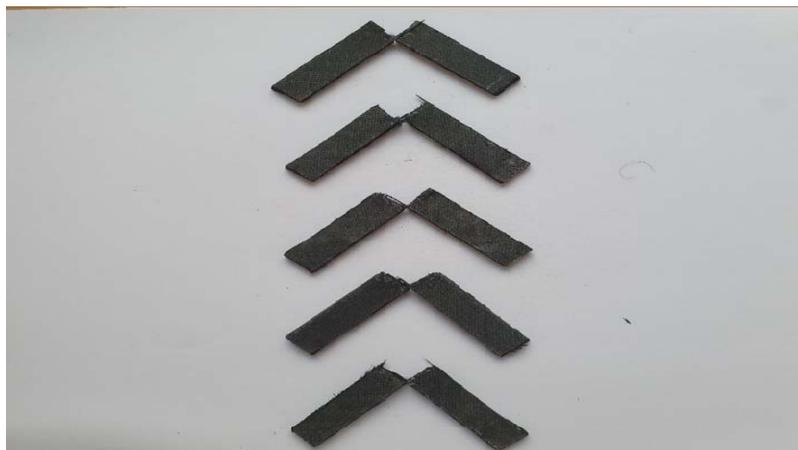
Fig.6. Charpy specimen after breaking.

The specimen was classified and arranged along with the test arrangement, then carefully removed from the fixture after the test was completed. The specimen breaking is shown in Fig.6.

The Charpy impact test results show that the carbon c-orthocryl specimens absorbed between  $1.899 J$  and  $2.668 J$  of energy before fracture, dissipated through mechanisms such as fiber breakage, matrix cracking, and delamination. Normalizing by the initial cross-sectional area yields impact toughness values ranging from  $0.068$  to  $0.086 J/mm^2$ , as shown in Tab.3 with an average of  $0.075 J/mm^2$  across the five specimens. The consistency of these values supports the reliability of the dataset and indicates that the material possesses moderate resistance to fracture under high-strain-rate loading. The specimens after breaking are shown in Fig.6. These findings underscore both the potential of CFRP for lightweight structural applications and its inherent susceptibility to impact damage, emphasizing the importance of toughness characterization in prosthesis design. Curing conditions, including time, temperature, and the specific environment, have a significant effect on the mechanical properties of CFRP. Mahfoud and Harb explored how varying curing cycles can influence the performance of carbon fiber composites, noting that optimizing the cure cycle can lead to enhanced mechanical properties. However, their study primarily focused on wave modes during curing rather than directly demonstrating enhanced impact resistance [49]. Similarly, the resin-hardener ratio plays an important role in determining the physical characteristics of the hardened composite. Zhang *et al.* reported that the addition of carbon nanotubes (CNTs) can catalyze the curing process, resulting in improved mechanical properties, including impact strength [50]. They highlighted that the optimal ratio of resin to hardener affects the degree of cross-linking, which is crucial for the final product's load-bearing capability. Moreover, the curing degree directly correlates with the mechanical performance of CFRP composites. Ye *et al.* observed that higher degrees of curing lead to notable improvements in flexural strength and impact resistance of epoxy-based CFRP composites, with increases in impact strength up to 82.9% when novel curing agents were introduced [51].

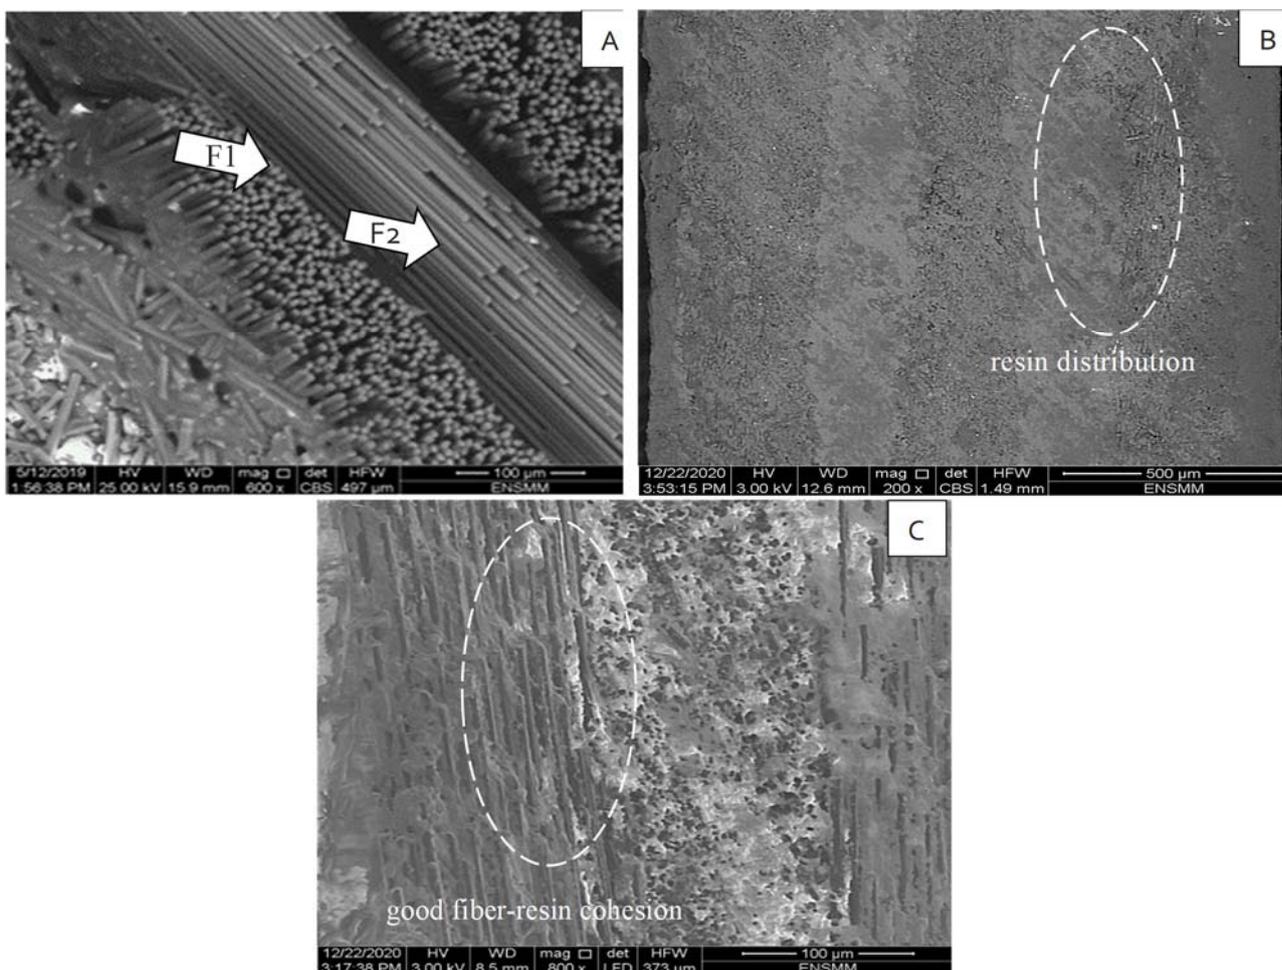
Fig.7. Cross-sectional views of control specimens highlighting multiple defects in three different planes. (A) Lack of resin through fibers in the frontal plane (1), (B) good distribution of resin in the transversal plane (3), (C) good fiber-resin cohesion in the longitudinal plane (2).

The three SEM images in Fig.7 effectively provide an overview of the composite material, carbon fiber, and c-orthocryl resin. Figure 7A, (F1), (F2) shows a significant defect inside the specimen in the frontal plane. Some of the fiber bundles are not immersed in the resin. This lack of resin will weaken the material and reduce its cohesion. Previous research [52] studied the influence of thermal residual stress and microscopic porosity on the transverse and longitudinal macroscopic properties of fiber-reinforced composites. This study employed a micromechanical modeling approach that incorporated artificially embedded triangular, circular, and square pentagonal pores. [53] Investigated the damage progression in carbon fiber-reinforced polymer (CFRP) generated by the effect of layup thickness on thin plates subjected to transverse tensile loading through a micromechanical modeling approach. The findings of their study indicated that, in the presence of pore defects, crack initiation takes place at the interface between the pores and the matrix, in addition to occurring at specific weak interfaces between the fibers and the matrix. The lack of resin and cohesion can have several origins, among others, a rapid gelling of the resin (resin/hardener ratio), a slow diffusion rate, etc.

Defects affect the ability to conclude the integrity of the composite. Figure 7B, on the other hand, shows a cross-section along the transversal plane, showing us a surface with a well-distributed resin between the fibers,

a sign of good infusion. Figures 7B-C show good fiber-resin cohesion in the longitudinal and transversal plane. Further investigation is needed to achieve better results.

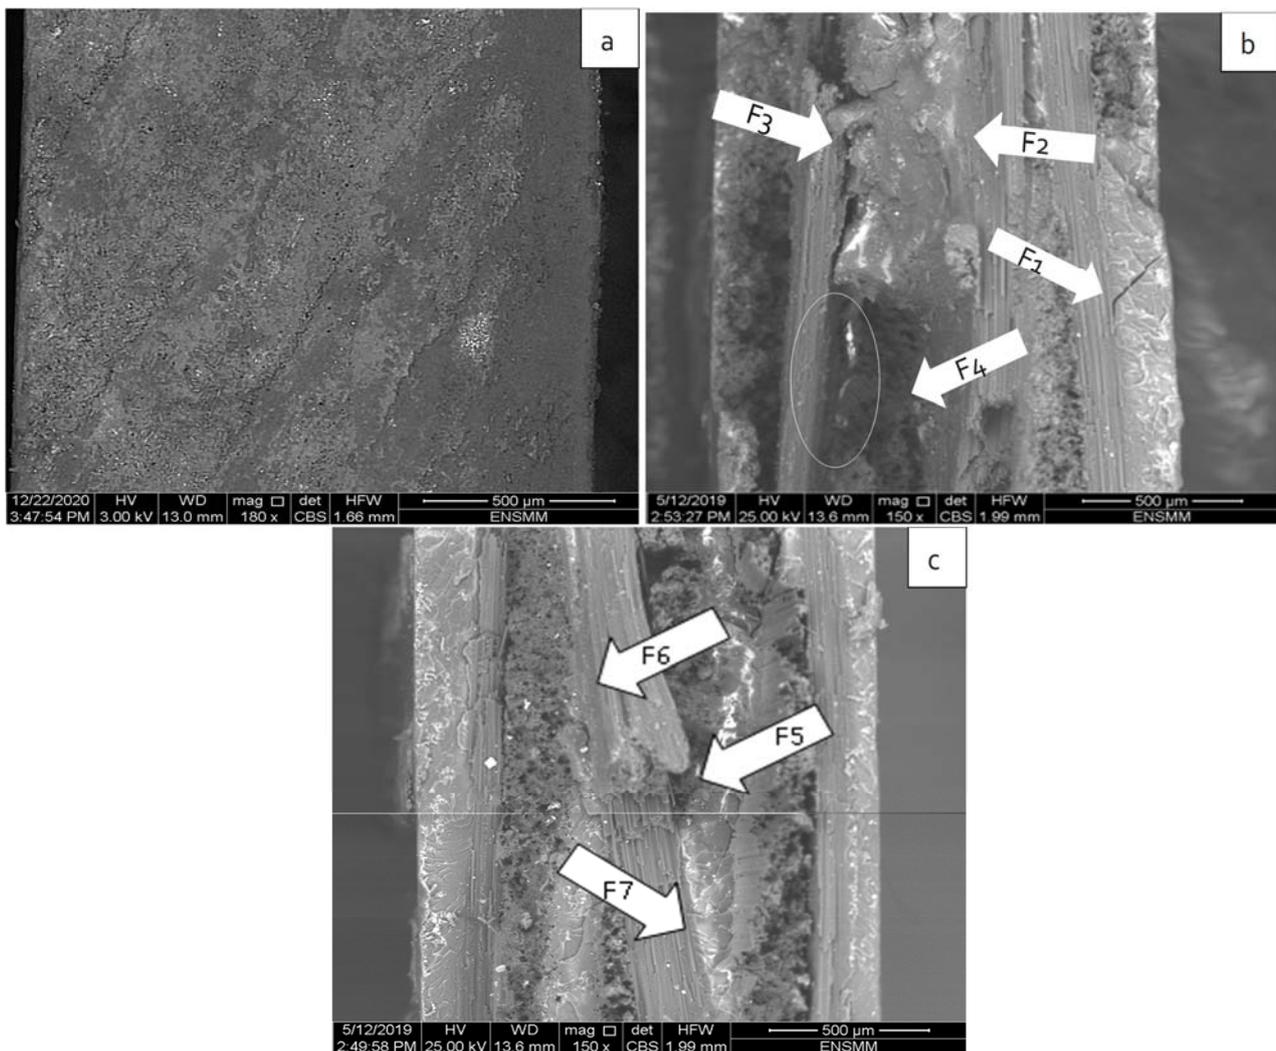
Fig.8. Cross-sectional views of the standard specimens after the static tensile test. (a) good molding infusion in the frontal plane, (b) resin cracking (F1) intralaminar, and translaminar delamination, and fiber failure (F2, F3, F4) in the fracture plane of the specimen, (c) fiber breakage, matrix decohesion, and good cohesion (F5, F6, F7) in the longitudinal plane.

The cross-section in the frontal plane shows a surface with a well-distributed resin between the fibers, as illustrated in the Fig.8a. Across the frontal plane, it covers the material well and has no detectable molding defects. The cross-section along the fracture plane of the specimen after tensile testing highlights the effect of static tension on the material, as shown in Fig.8b. These effects are manifested by resin cracking (F1), intralaminar delamination (F2), translaminar delamination (F3), and fiber bundle failure (F4), which is due to plastic deformation during the test. Wen *et al.* highlight that during tension, where the fiber-matrix interface starts to debond and leads to crack initiation under load [54], resulting in intralaminar delamination.

The combined effect of these two types of delamination contributes to fiber breakage, which leaves a crater in the material (F4). This fiber breakage is manifested by the disappearance of fiber bundles at various levels. This demonstrates the effect of the static loading after the specimen breakage. It weakens the material and generates different types of damage. Figure 8c shows a breakage of a fiber strand along the tensile axis (F5), as well as a fiber matrix decohesion (F6). It also shows good fiber-matrix cohesion, due to effective infusion and resin-reinforcement compatibility (F7). Tensile damage is severe, damaging both the resin and the fibers.

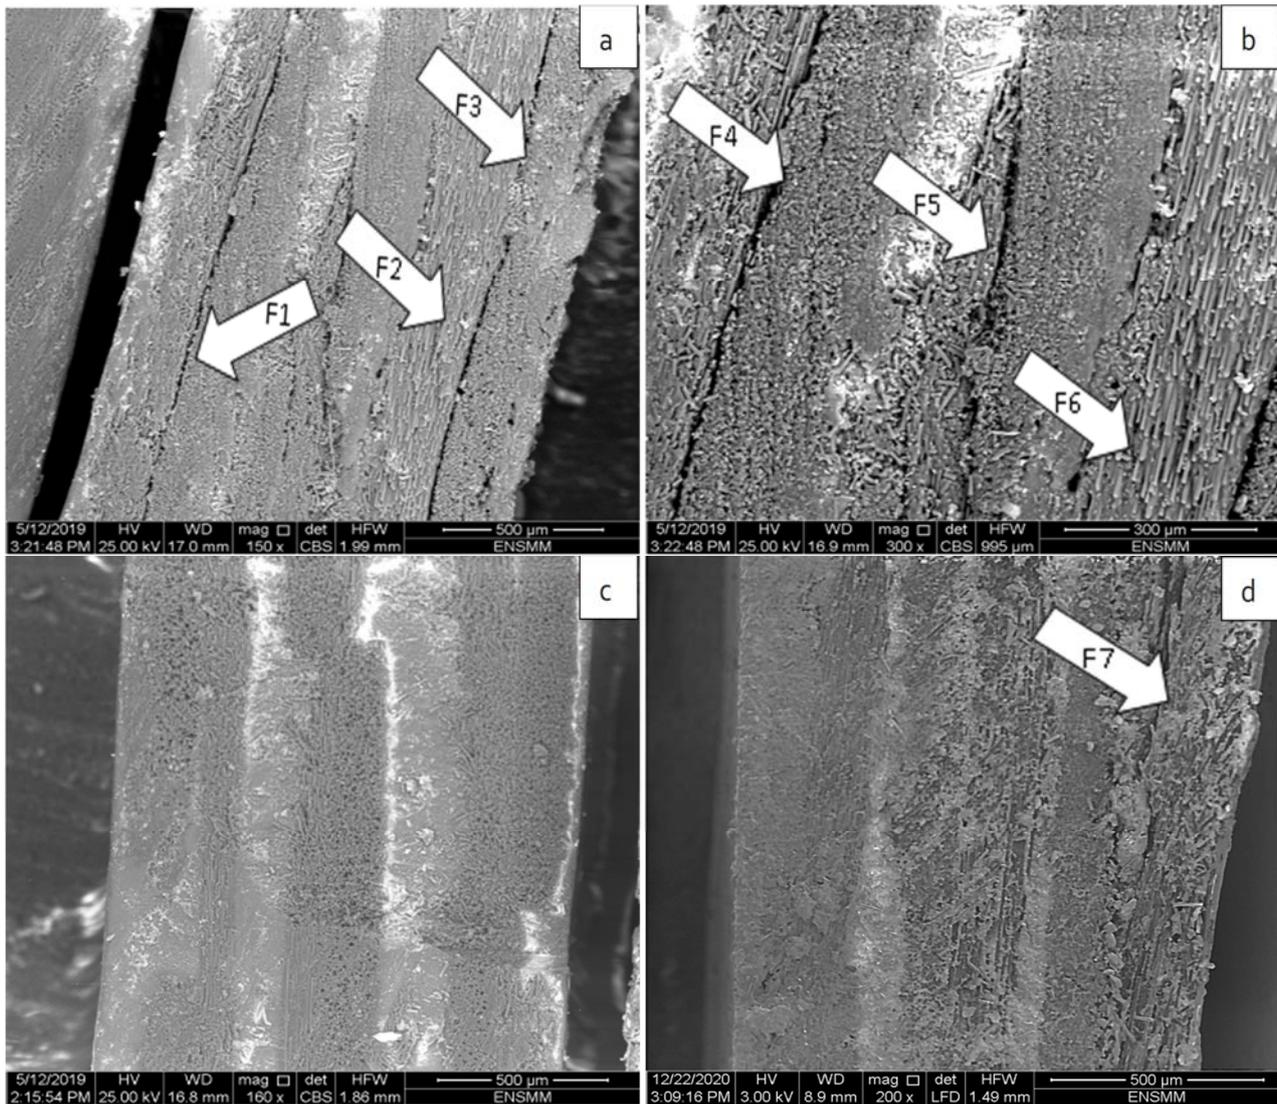
Fig.9. Cross-sectional views of the drilled specimens before the static tensile test. (a, b) double interlaminar delamination (F1, F2), and resin stripping F3 in the transversal plane of the bore hole, (c) good cohesion along the longitudinal plane, (d) the propagation of the cracking F7 in the cross-section by width.

Figure 9a shows the classic double interlaminar delamination at the borehole (F1 and F2). This double delamination is caused by the drill bit during drilling, which causes mode one cracking by lifting the first ply.

The same phenomenon occurs when the drill exits and lifts the last ply, creating the second delamination in mode one. Aamir *et al.* confirmed that the HSS drill-bit could cause these two types of delamination, which occur between different layers and generate excessive built-up edges [55]. Ghazali *et al.* elucidate stated in their research that variations in tool material potentially mitigate both intra- and interlaminar delamination [56]. We also see resin stripping on the lower lip (F3). Figure 9b shows inter (F4) and intralaminar delaminations (F5) and brushing of the carbon fibers after they have broken in the direction of rotation and cutting of the drill bit during drilling (F6). Figure 9c shows good cohesion between the resin and the fibers along the length of the specimen. Figure 9d shows the propagation of interlaminar cracking (F7), caused by the drilling.

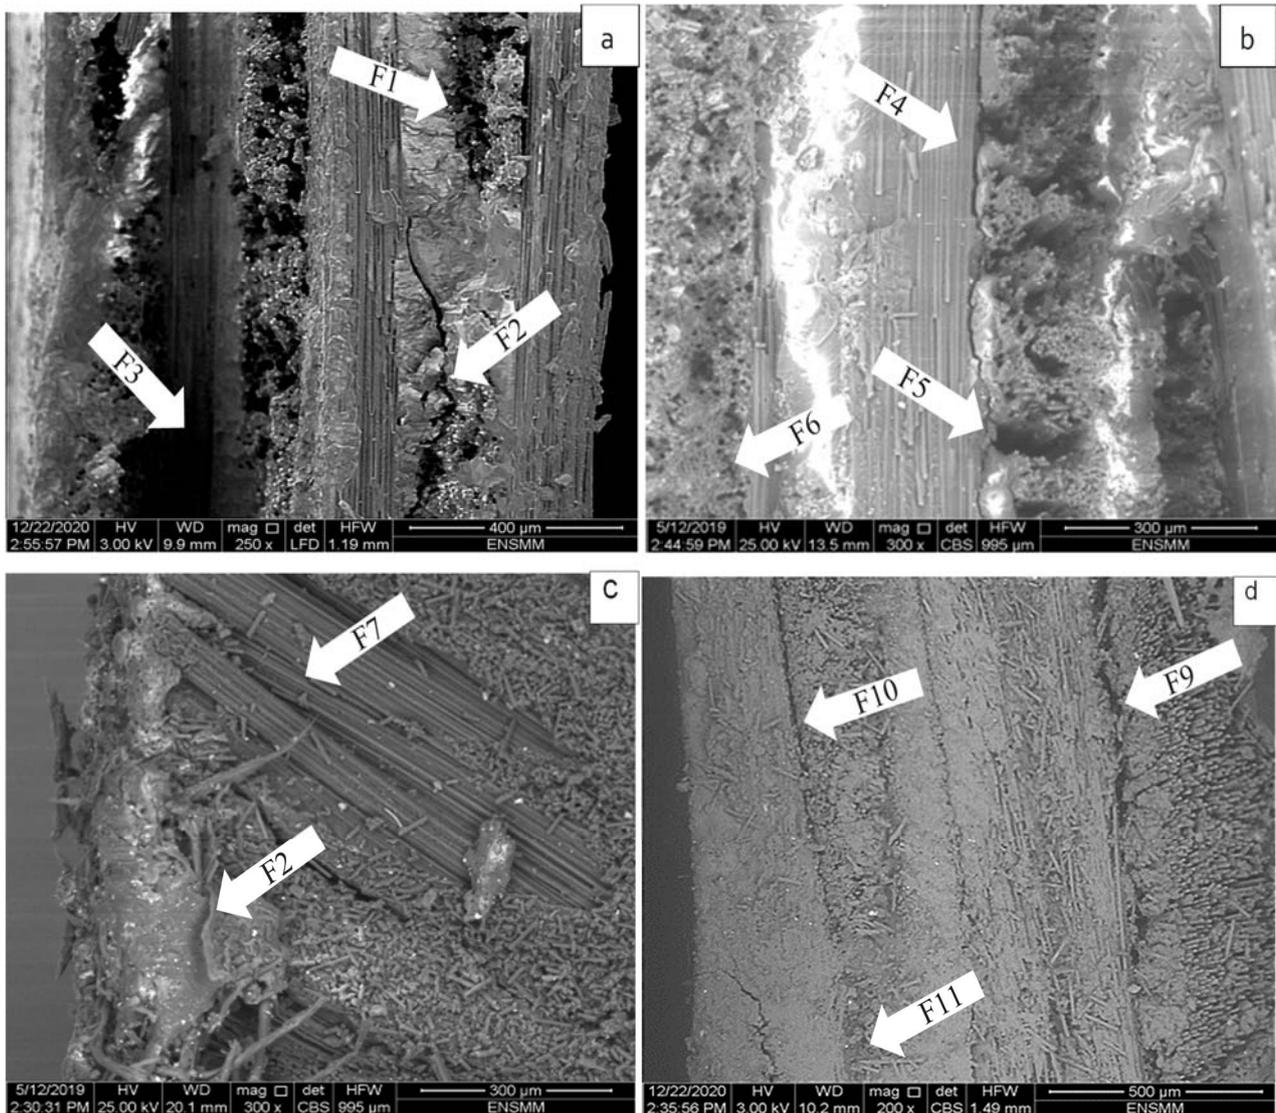
Fig.10. Cross-sectional views of the drilled specimens after the static tensile test. (a) matrix cracking F1 with intralaminar delamination and fiber strand pull-out (F2, F3) in the transverse plane by width, (b) interlaminar delamination with fiber push-out (F4, F5) in the longitudinal plane according to length, (c) fiber tearing (F7) in the cross-section (4) fracture plane of the specimen, (d) inter and intralaminar delamination (F9, F10, F11) in the transversal plane at the bore hole.

Figure 10a shows matrix cracking perpendicular to the drilling axis (F1), with the creation of an intralaminar delamination (F2), and a fiber strand pull-out (F3). Wang *et al.* reported the cause of this complex damage to the drilling, which affects the resin-matrix bonding [57]. Figure 10b shows interlaminar delamination (F4) and fiber strand push-out (F5). We also notice a fiber-matrix decohesion (F6). Figure 10c shows the tearing of a fiber strand with its resin (F7) and an intralaminar delamination (F2) due to the tensile stress concentration. Additionally, the bond quality between the matrix and the strands impacts directly the occurrence of these types of delamination's which significantly decreases the mechanical performance under tension [58] Figure 10d shows interlaminar (F9, F10) and intralaminar (F11) delaminations caused by drilling with matrix failure caused by material embrittlement due to the effects of drilling and tensile stress. Drilling and tensile stresses cause extreme material degradation and embrittlement.
